**STATEMENT OF PETER AMES EVELETH
GENERAL COUNSEL, OFFICE OF COMPLIANCE
BEFORE THE SUBCOMMITTEE ON THE LEGISLATIVE BRANCH,
HOUSE APPROPRIATIONS COMMITTEE
July 8, 2008**

Capitol Visitor Center
Office of Compliance
Pre-Inspection

**Eveleth Statement
Attachment 2**

Office of Compliance CVC Pictures

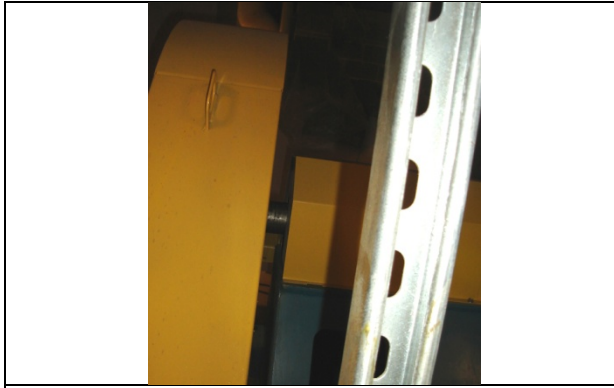
| Hazard No. | Observed Date | Location | | OOB Finding | Applicable Standard | OOB's Proposed Solution | Abatement Status | AOC Comments |
|---|---|---|--|---|--|--|---|--|
| 25 | 3/27/2008 | On the service level | Air handling fan drive shafts in mechanical area | Machine guarding for air handlers RF-13, CVRF-15, CVRF-16, CVEF-14, and CVRF-17 on the drive shafts for these machines is inadequate because there are openings of 2 and 3 inches where the rotating shaft is not guarded. There is openings where a person can have their fingers or hand contact the shaft. | 29 CFR 1910.219.(c)(2) | Install appropriate guarding over the drive shafts of each of these air handlers. | Abated | |

Hazard: Exposed rotating shaft not compliant with 29 CFR § 1910.212(a)(1).

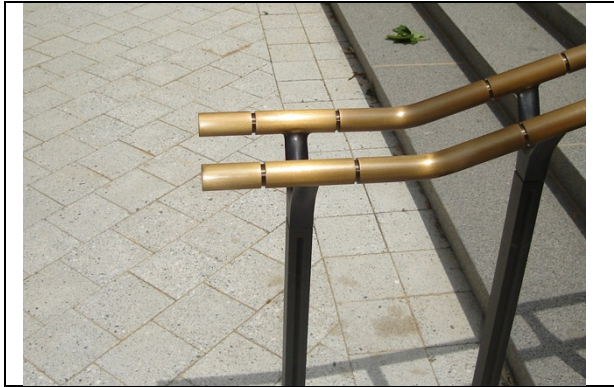
| Hazard No. | Observed Date | Location | | OOB Finding | Applicable Standard | OOB's Proposed Solution | Abatement Status | AOC Comments |
|---|---|---|--|---|--|--|---|--|
| 14 | 2/21/2008 | (whole facility) | Exterior and interior stairways' handrail ends | A number of stairway handrail systems are not in serviceable condition. They present a projection hazard where visitors and employees could be injured if they run or fall into this part of the handrail. | 29 CFR 1910.23(e)(5) | Replace the handrail system's end piece so it curves back to the wall or to the post and does not project out beyond the stair steps and into the walkway area. It needs to be secured and properly mounted to provide the required protection features. | Under Discussion | NFPA does not require turning rails back to the wall in non-egress stairs. CVC has worked with OOC to determine locations which might be considered projections hazards. Cost is approximately \$50,000. |

Hazard: Protruding handrails create projection hazard not compliant with 29 CFR § 1910.23(e)(5)(i), 2000 NFPA 101 7.2.2.4.5, ANSI/ASSE A1264.1-2007 Section 5.8 and ASTM E 985-00 Section 4.3.2.

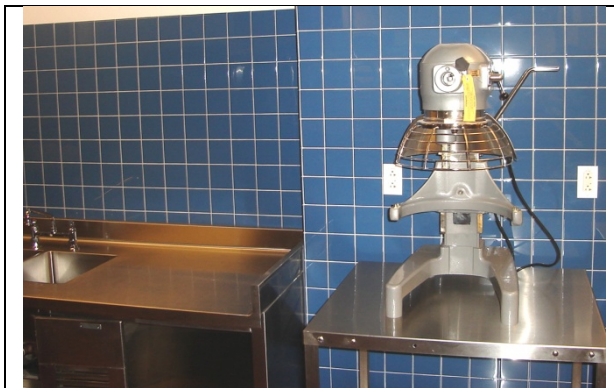
Hazard: Outlets are not protected with Ground Fault Circuit Interrupters, which are required in kitchens due to wet floors by 1999 NFPA 70E Section 110-10.
Solution: Install low cost GFCI outlets in the kitchen and near all water sources.

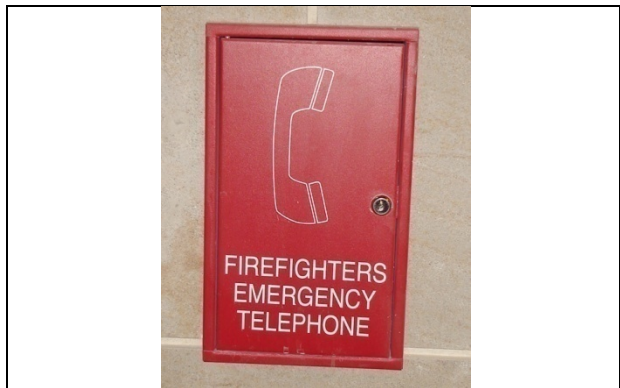
Hazard: Telephones at staging areas are locked, prohibiting use.
Solution: Change lock on cover into a knob or handle that is compliant with 28 CFR Part 36 Appendix A Section 4.27.4.

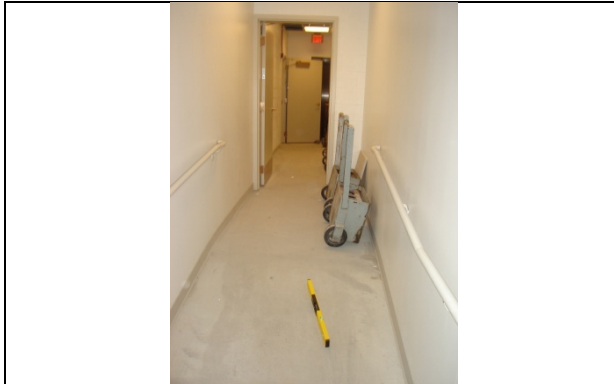
Violation: Ramp is too steep for individuals in wheelchairs and does not comply with 28 CFR Part 36 Appendix A Section 4.8.2.
Solution: Regrade ramp equal to or less than 8.3% grade.

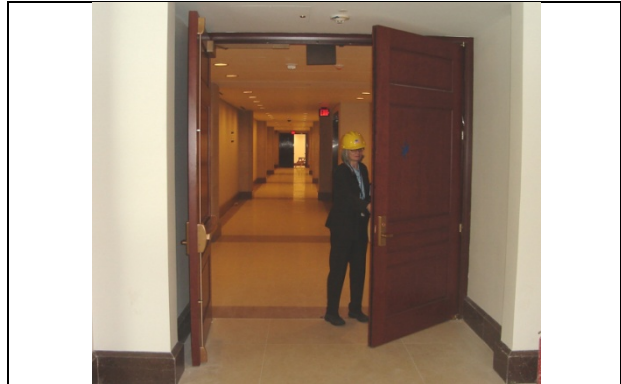
Hazard: Door swings against direction of egress travel, which does not comply with 2000 NFPA 101 7.2.1.4.2.
Solution: Rehang door to swing in the direction of egress travel.

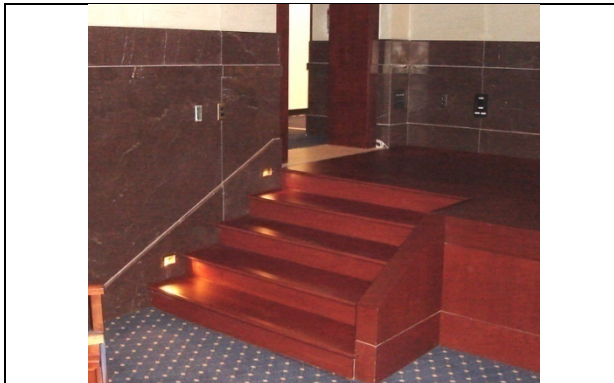
Hazard: Stairway with greater than 4 risers has no handrails, not complying with 29 CFR § 1910.23(d)(1).
Solution: Install handrails compliant with 29 CFR § 1910.23(d)(1).

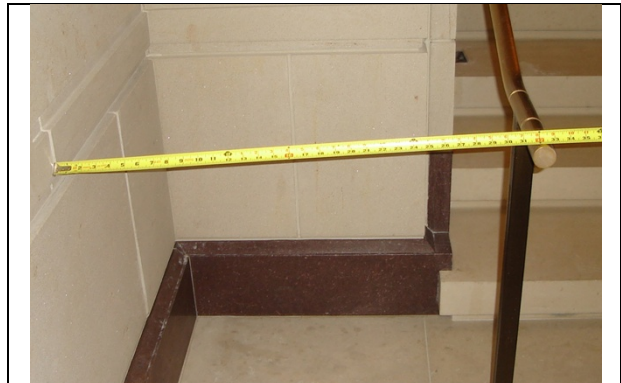
Hazard: Handrail protruding into open space in room.
Solution: End handrail at bottom riser and make compliant with 29 CFR § 1910.23(e)(5)(i), 2000 NFPA 101 7.2.2.4.5, ANSI/ASSE A1264.1-2007 Section 5.8 and ASTM E 985-00 Section 4.3.2..
