# **BIENNIAL REPORT 111<sup>th</sup> CONGRESS**

## **AMERICANS WITH DISABILITIES ACT INSPECTIONS RELATING TO PUBLIC SERVICES AND ACCOMODATIONS**

**Office of Compliance  
August 2012**

# **Accessibility in the Legislative Branch – Report on Americans with Disabilities Act Inspections Relating to Public Services and Accommodations during the 111<sup>th</sup> Congress**

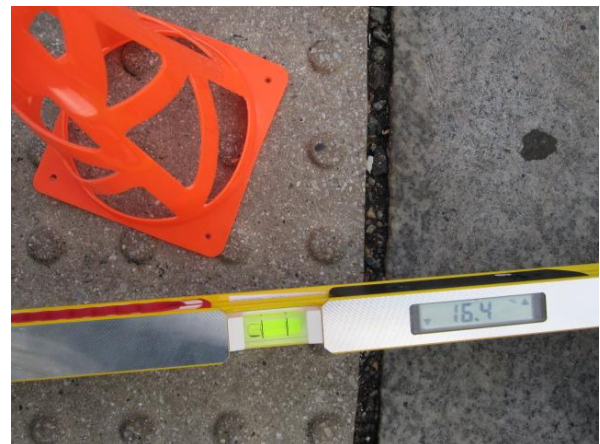
**Curb Ramp 14 has a Running Slope of 16.4%**

by both the 1991 and 2010 Standards.<sup>9</sup> In two cases, the deviation from the applicable Standard is rated as an “A” severity because the slope far exceeds the maximum: Curb Ramp 12 has a 14% slope and Curb Ramp 14 has a 16.4% slope. Three of the curb ramps with excessive running slopes have a severity code of “B” -- which means that the deviation from the standard is severe enough to block access. Curb Ramp 13 has a running slope of 10.6% and Curb Ramp 23 has running slope of 10.5%. One curb ramp, Curb Ramp 39, has a running slope classified as a “C” severity, meaning that it is a major inconvenience, because the slope is 11.2% (more allowance is allowed to its size – see Guidelines in Table 2).

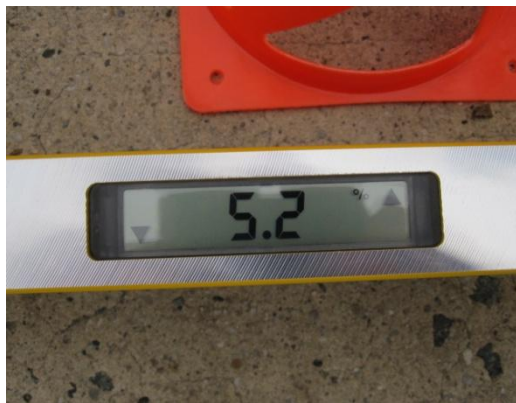
The OOC identified 13 ramps with cross slopes that are too steep. This means there are areas on each of these curb ramps that exceed the maximum allowable cross slope of 2.08% or 1:48. In 6 of these ramps, the cross slope of the ramp itself exceeds the standard, in 5 ramps the cross slope of the top landing exceeds the standard, and in 4 ramps the cross slope of the bottom landing exceeds the standard. 3 ramps have excessive cross slopes at all three locations, and 2 ramps have excessive cross slopes on the ramp itself or at the top or bottom landing. For each of these ramps, the deviation from the standard is so severe that an “A” severity condition has been created in one or more locations.

Curb Ramp 40 Has a Cross Slope of 5.2%

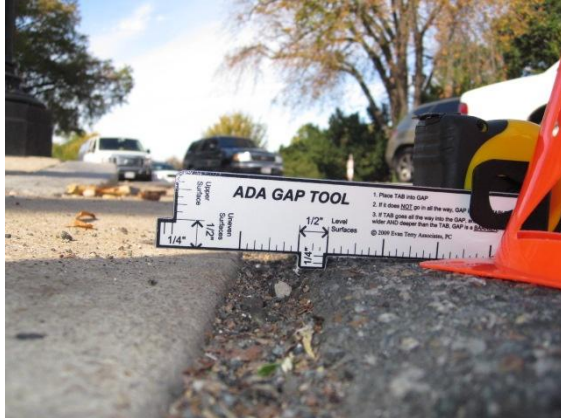
The OOC found 12 curb ramps with barriers related to concrete slab joints, cracks or transitions. Slab joints that are greater than 1/2 inch wide or 1/4 inch deep create barriers to access because the small anti-tip wheels on wheelchairs can catch in these spaces. Similarly, when transitions between the ramp and the sidewalk or the road are not level, the front foot rest can catch and cause the wheelchair to flip forward.

Slab Joint Too Wide & Too Deep (Curb Ramp 20)

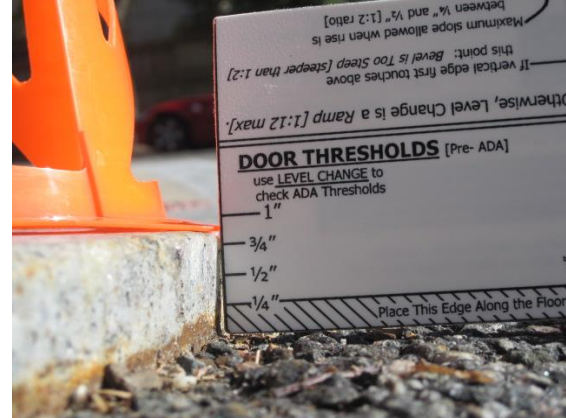
Transition Too High (Curb Ramp 27)

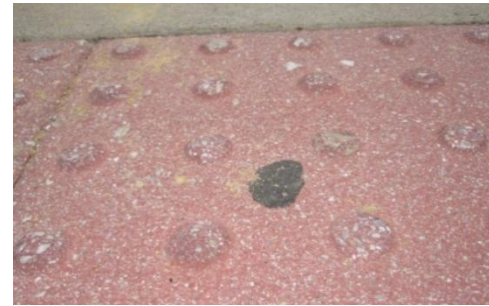
The OOC found 8 curb ramps with detectable warnings that had deteriorated. While these are only rated as “C” severities, these deteriorated warnings do make it more difficult for the ramp to be detected by people who use canes because of visual impairments.

Deteriorated Detectable Warning (Curb Ramp 39)

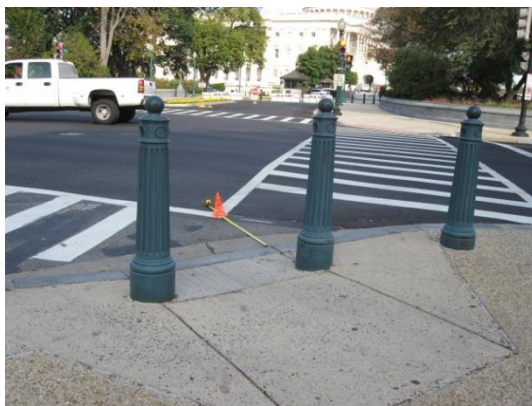
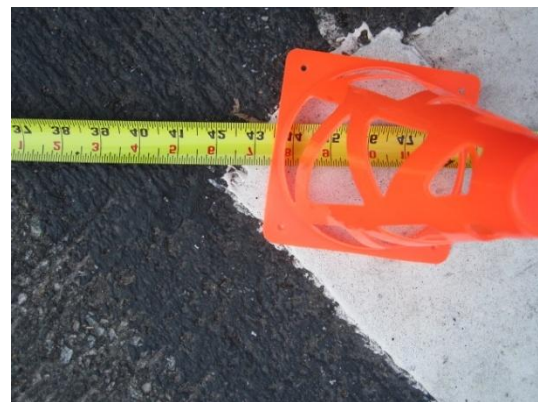
The OOC found 4 curb ramps where not enough of the ramp was within the marked crosswalk. These all involved diagonal (or corner) type curb ramps where one curb ramp is serving two marked cross walks. The standards require at least 48 inches of the bottom landing to be within the marked crosswalks.

Ramp Outside of Marked Crosswalk (Curb Ramp 16)

Close-up of Tape Measure in Previous Photo (Curb Ramp 16)

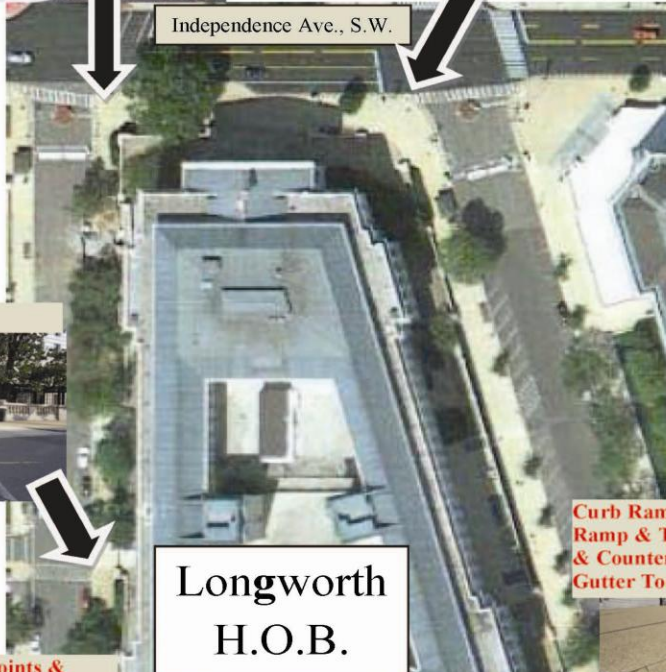
**No Curb Ramp (B)**

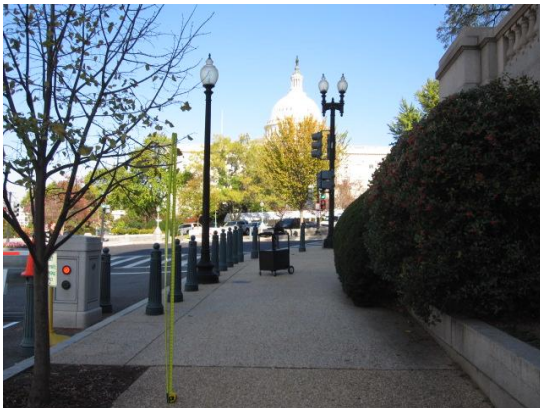
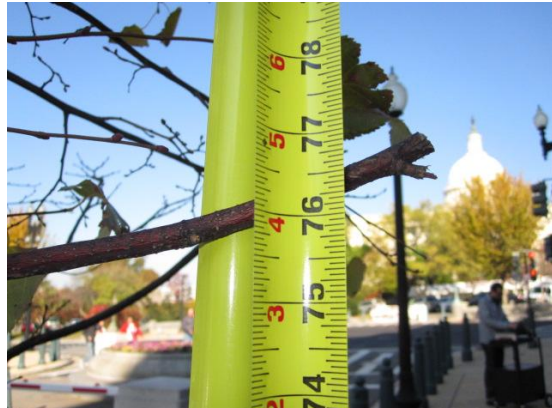
**Protruding Tree Branch Creating Barrier**

**Close-up of Tape Measure in Previous Photo**

The OOC found 11 barriers relating to objects that protrude into the sidewalk corridors. Most of these are related to tree branches or plants that have grown into the corridor. Two of the 11 barriers are rated as “A” severities because, in one case (Barrier 88), the tree branch is thick enough to pose a cutting hazard, and in the other case (Barrier 129), the protruding ledge has a rough surface that could cause abrasions during contact. Of the remaining 9 barriers, 8 are rated as “C” severities while 1 is rated a “B” severity.
