BIENNIAL REPORT 113TH CONGRESS

AMERICANS WITH DISABILITIES ACT INSPECTIONS RELATING TO PUBLIC SERVICES AND ACCOMMODATIONS

OCTOBER 2016

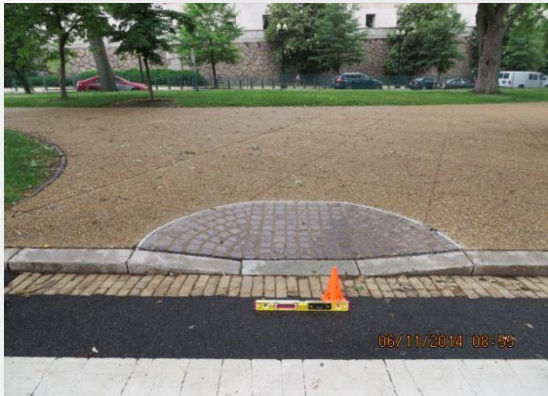
Figure 2. A Capitol grounds curb ramp with a cross slope that is too steep.

When a ramp is too steep, a wheelchair going down the ramp can flip forward at the bottom of the ramp when the foot rest catches on the ground where the ramp meets the street.

Conversely, when going up a ramp that is too steep, a wheelchair can flip backwards due to the abrupt changes in grade.

When the curb ramp slopes steeply sideways (the cross slope), wheelchairs can fall over to the side or be pushed out of the crosswalk and into traffic.

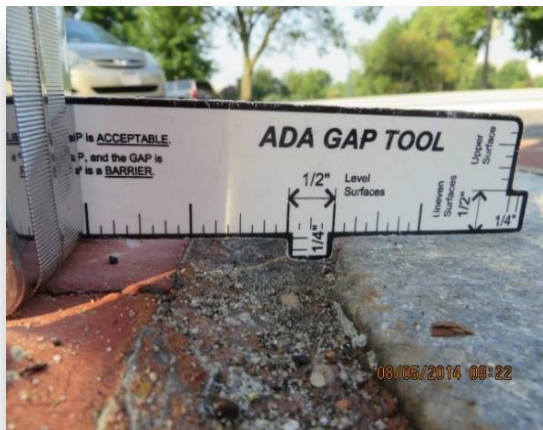
Figure 3. A curb ramp with a wide crack/gap located on the southeast side of the Capitol Building.

When there is an abrupt change in level between the curb ramp and the adjoining pathway, wheelchairs may become unstable.

Deep or wide cracks and gaps can trap the small steering wheels on wheelchairs or the even smaller anti-tip wheels on motorized wheelchairs and cause stability and control problems for the user.

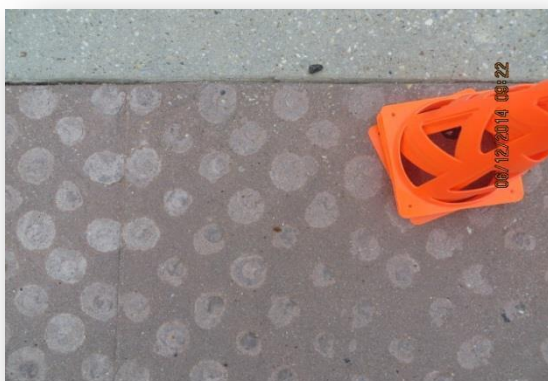
Figure 4. Deteriorated detectable warning domes on a curb ramp located on the southwest side of Capitol Building.

When the detectable warning domes on curb ramps wear down or are missing, blind or low vision pedestrians may have difficulty discerning where to enter and exit a sidewalk.

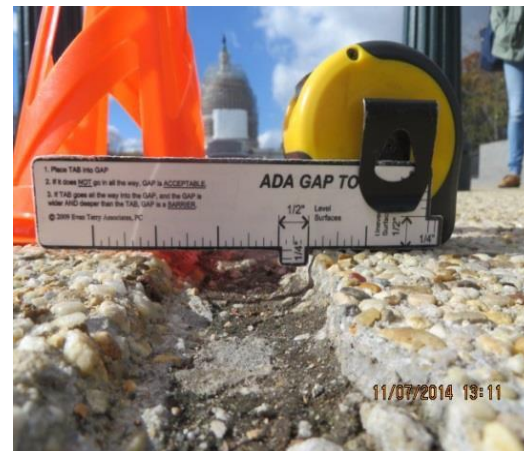
These types of barriers can impact stability in a number of ways. When the vertical height of the surface material changes abruptly, such as at the uneven joints between concrete slabs or at grooves, cracks, or holes in the surface, ambulatory pedestrians can trip, wheelchair casters can catch (causing the chair to abruptly stop) and people who are blind or have impaired vision can fail to anticipate the change and fall. Steep cross slopes make it difficult for people using wheelchairs and some pedestrians to keep their lateral balance because they must work against the force of gravity. Severe cross slopes can also cause wheelchairs to veer to the side, which increases the risk of rolling into the street.

Figure 5. A wide gap within the expansion joint of a sidewalk on the east side of the Capitol.

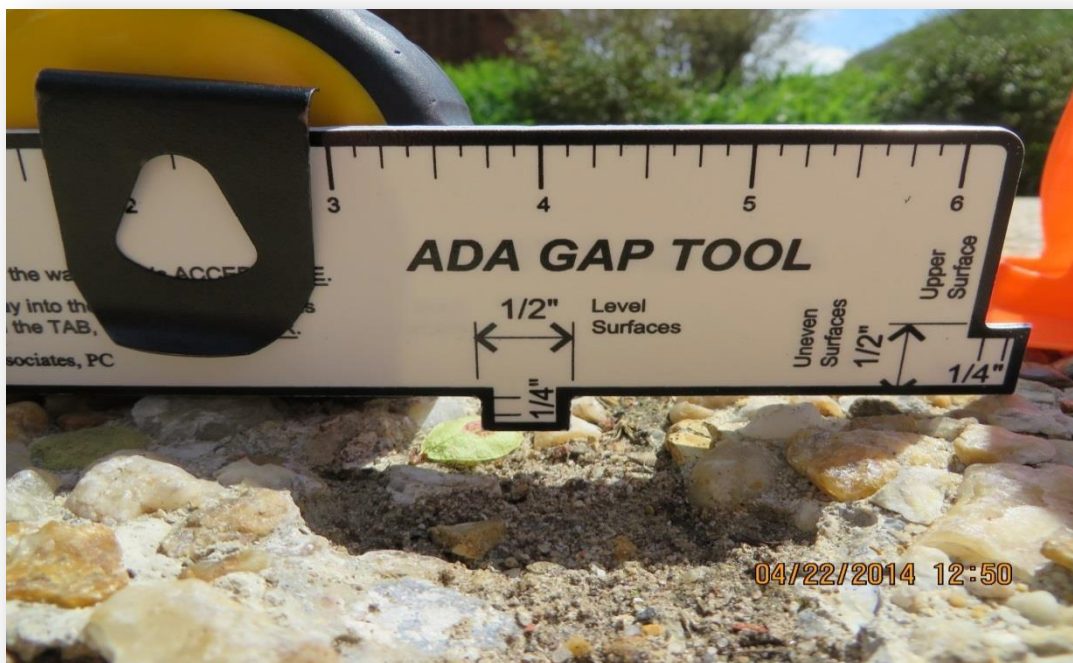
Figure 6. A Capitol grounds expansion joint gap measurement.

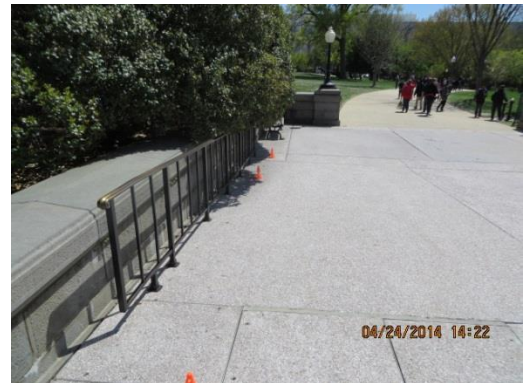
Ramp barriers can impact the stability of a person traveling with a mobility aid device in many of the same ways that curb ramp and exterior route barriers do. An elevator door reopening function that does not keep the elevator open for a sufficient length of time may cause injury if the doors

Figure 7. A ramp on the Capitol grounds with foliage obstructions to the handrails.
