114TH CONGRESS

Accessibility Report

BIENNIAL REPORT ON AMERICANS WITH DISABILITIES ACT INSPECTIONS
RELATING TO PUBLIC SERVICES AND ACCOMMODATIONS

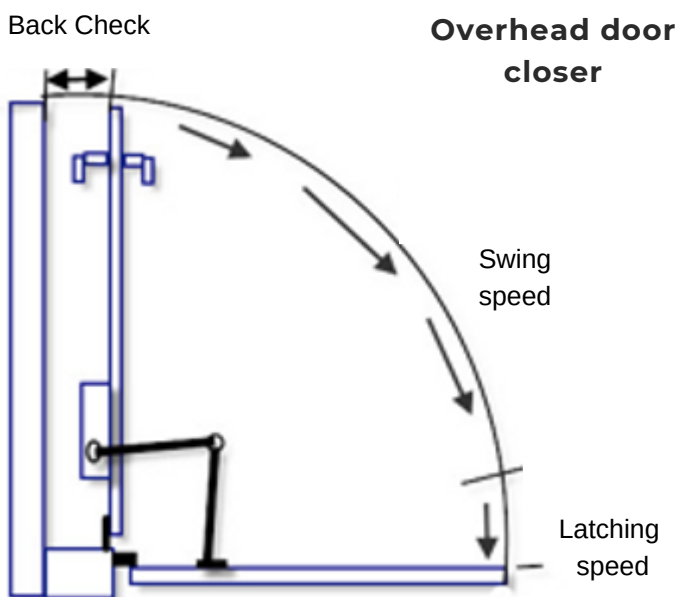
One of the building-wide Member office issues that we saw in Hart was office and suite doors that required too much force to open and/or closed too quickly. The problem with such doors is that they are difficult to open if you are someone with limited upper body strength or an impairment that affects the use of your hands. Further, persons who use wheelchairs, walkers, or other mobility devices may not be able to pass through such doors fast enough.

Barriers related to the opening force and closing speed of doors can usually be resolved by making adjustments to the overhead door closer.

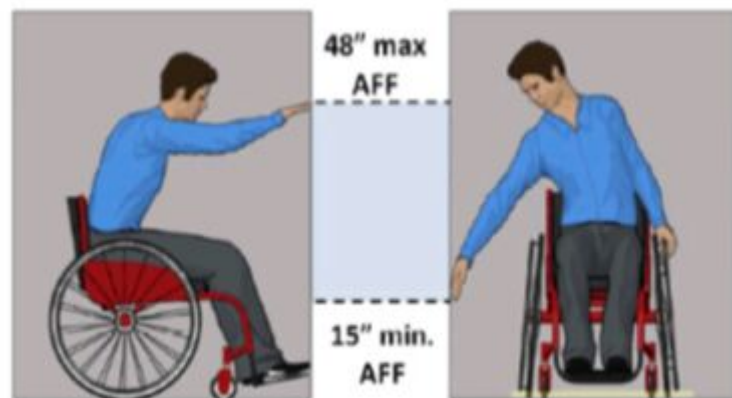
Reach Ranges (§308)

There were a relatively low number of barriers identified in the Dirksen Member offices. Inspectors found just 3 barriers and they all related to literature or magazine stands being positioned outside of the required reach range.

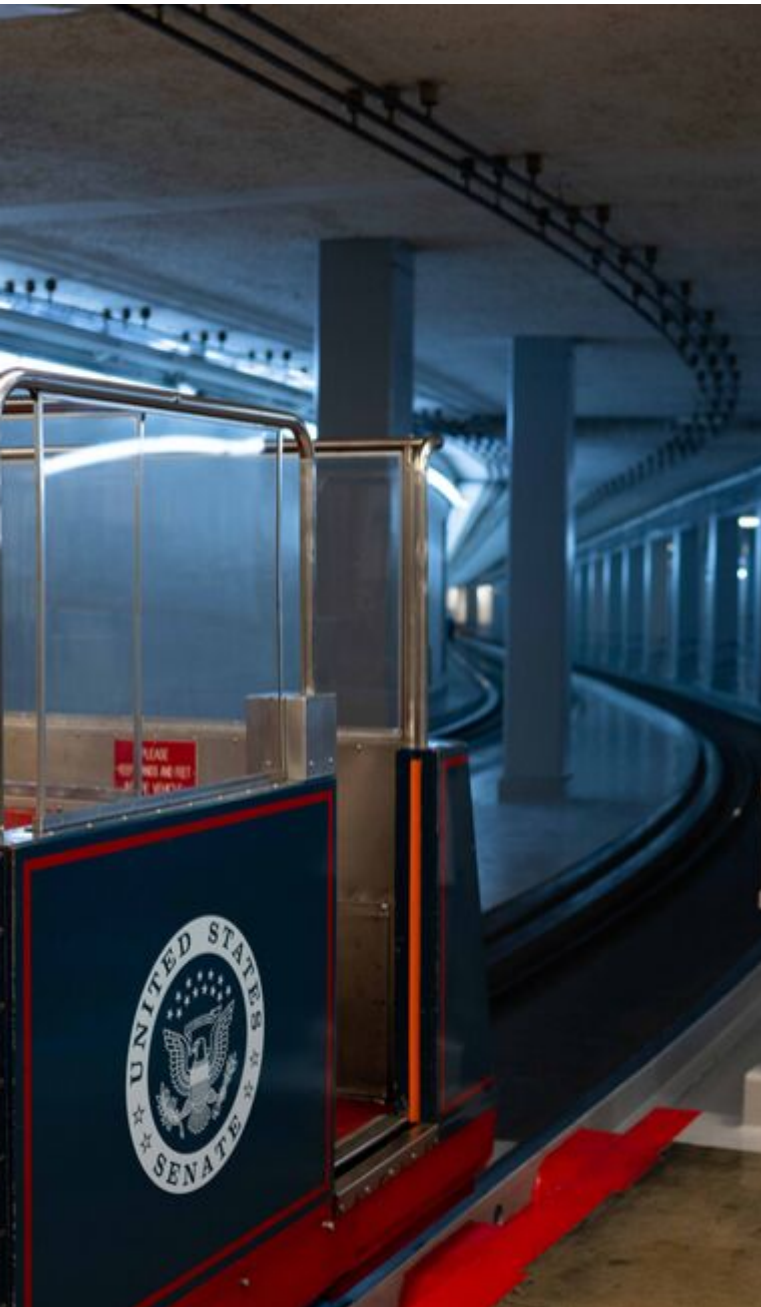
The transportation barrier category was particularly concerning. We found that there were no detectable warnings at the subway platform boarding edges.

Because the Senate subway platform boarding edges do not have platform screens or guards, detectable warnings are necessary to alert a visually impaired person that they are close to the edge. Without them, a visually impaired person could unknowingly step into an unsafe area.
