*Office of Compliance*  
**Report on Occupational Safety  
and Health Inspections**

Conducted in the Legislative Branch during the 108th  
Congress pursuant to the Congressional  
Accountability Act

*October 2005*

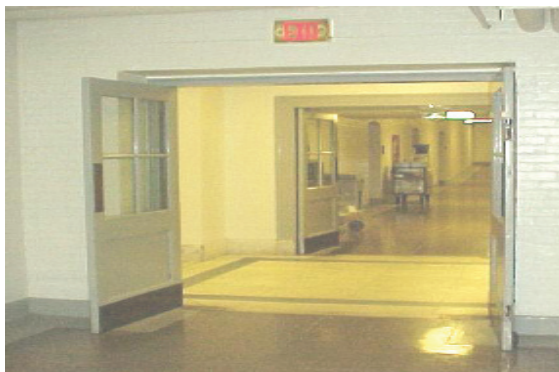
The 2004 inspection noted some improvement in the Capitol. As recommended by the OGC inspectors, two exit stairways from the fourth to the first floors of the Capitol building were fully enclosed and protected. Exit capacity was enhanced by installing side-swing doors in place of revolving doors. However, a recent on-site inspection noted that the enclosure of the stairwells was compromised. In one instance the door latch had been disabled; in another, the door was blocked open with a brass stanchion.

*Non-fire doors in a Legislative Branch Building offer no protection during a fire; doors are also held open by brass pegs allowing toxic smoke to flow freely.*

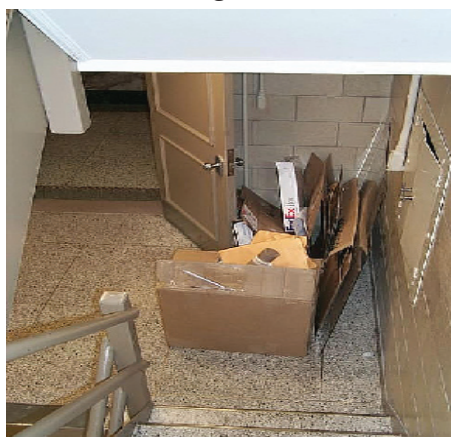
The inspectors found that stairwells in the Supreme Court Building that serve as emergency exit routes for AOC employees were partially blocked by cardboard boxes and paper files stored within a metal file cabinet. This created a dual hazard - blockage and combustible materials.<sup>16</sup>

*Combustible materials being stored in an exit stairwell.*

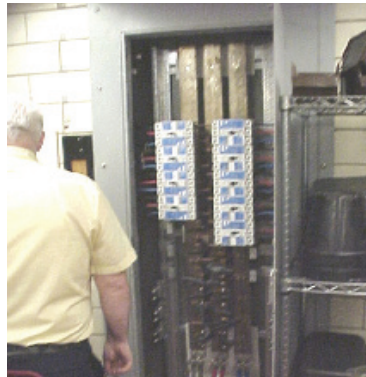
The inspection team identified 170 hazardous electrical boxes, outlets, and switches with exposed, energized wires. Many of these wires were within employee reach. A majority of these hazards qualified as RAC 2 in severity requiring prompt correction. Several qualified for RAC 1 in severity requiring immediate attention. As discussed in the Executive Summary of this Report, the number of high RAC ratings is surprising. See Section I.D. A Notice of Serious Deficiency Needing Prompt Attention was issued to the AOC for an open electrical box inside a dark area with exposed and energized wires hanging from a low ceiling in the E Street Building. This hazard was promptly abated by the AOC.

*Blanks missing in electrical panel exposes employees to live contacts.*

Hazards of this type were specifically noted in the 1998 and 2002 Reports. 1998 Report, p. 21; 2002 Report, pp. 39-40. Many remain unabated.

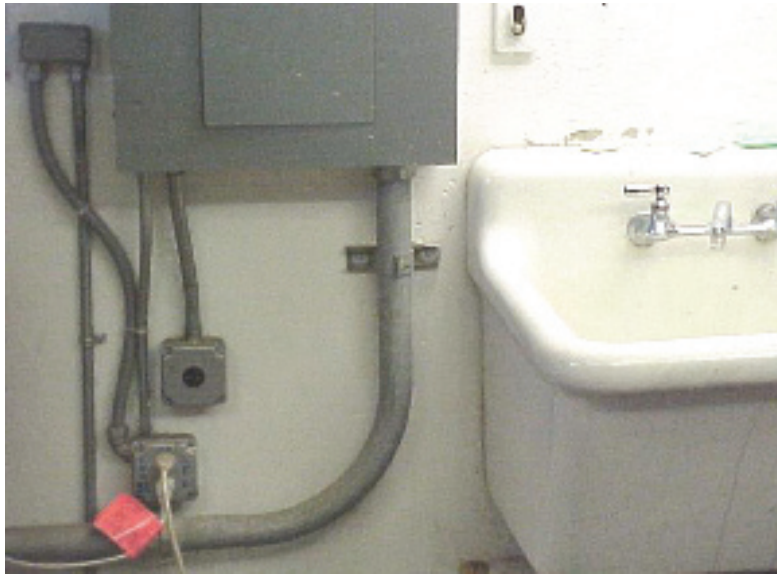
Ground fault circuit interrupters (GFCI) protect employees from electrical shock hazards when working around or near wet or damp locations. Without a GFCI, a faulty electrical appliance could deliver a fatal shock. The installation of GFCIs on outlets is relatively simple and inexpensive. However, the 2004 inspections found that 120 locations needed the installation or replacement of faulty ground fault circuit interrupters. Three Serious Deficiency Needing Prompt Attention Notices were issued to the AOC in this regard.

*Electric outlet near sink is not a ground fault circuit interrupter (GFCI).*

The 2002 Report addressed the importance of installing GFCIs throughout Legislative Branch buildings. The 2004 inspection revealed an overall increase in their number. However, the number of hazard findings indicates that further improvement is necessary. In particular, all employing offices must incorporate periodic inspection and maintenance of these important safety devices.

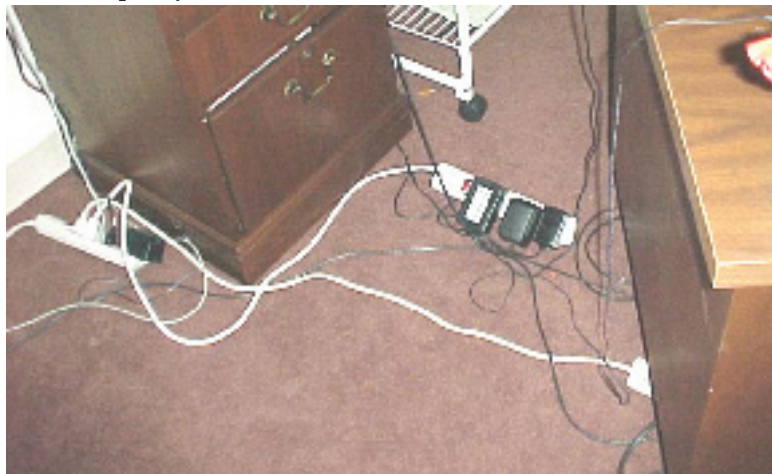
The 2004 inspection revealed a continuing practice in all inspected facilities that creates a significant fire hazard. A total of 450 locations were found to be using extension cords as permanent wiring or creating a “daisy chain” wherein power strips or surge protectors were linked to extend their reach or increase capacity.

*Daisy chain of power strips to create additional outlets.*

Both of these conditions violate the National Electrical Code and OSHA requirements. 29 C.F.R. §1910.303 and NFPA 70-1999, §305-3. These *advancing safety, health, and workplace rights in the legislative branch*

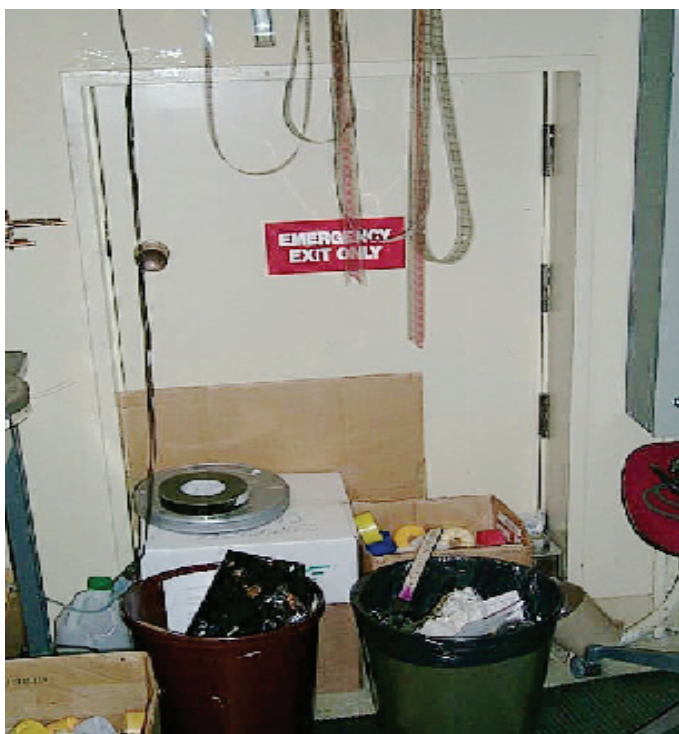
The inspection team documented twelve violations regarding non-compliant fire doors in the Dirksen Building. These deficiencies stemmed from blocking fire door exits, propping open fire doors that are designed to be self-closing, and self-closing doors that required maintenance in order to close and latch properly. A Notice of Serious Deficiency Requiring Immediate Attention was issued to the AOC on October 13, 2004, for a blocked exit off of the Senate Dining Room. The rear exit doors, which serve as an alternate emergency exit for large numbers of building occupants, were blocked in order to create a space to store paper records.

*Exit door is blocked by combustible materials.*

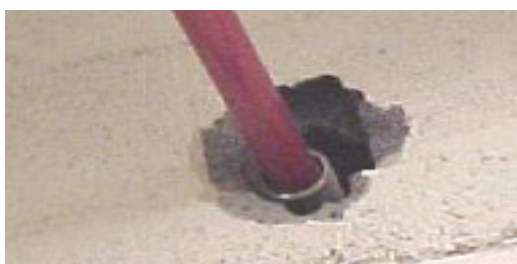
Breaches into fire walls negate the efficacy of the protection afforded by the barrier by allowing smoke and toxic gases to pass through the holes. On the positive side, the number of penetrations decreased substantially from the time the last comprehensive fire safety inspection was conducted in the Dirksen Building in 1999. However, the OGC inspection team discovered eight holes and penetrations in various fire walls throughout the building that were apparently caused by contractors installing security or other devices, such as cable, and then failing to fire-stop the openings when the project was completed.

*Holes or penetrations through fire wall.*

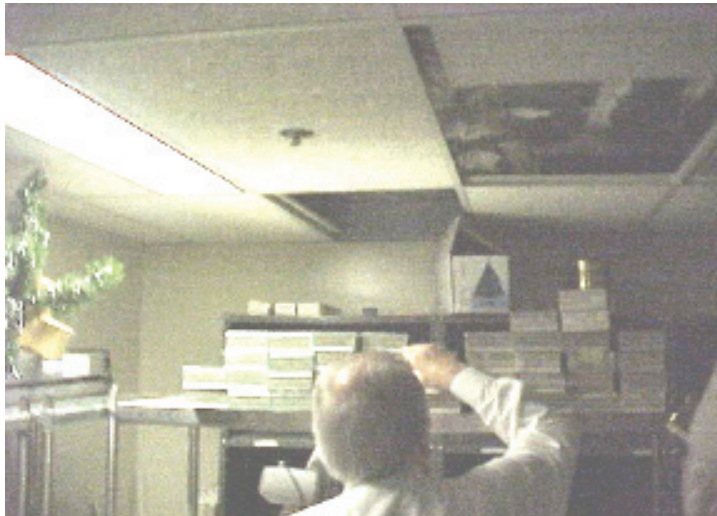
Several deficiencies were noted in the Dirksen Building's sprinkler system. The building itself has extensive coverage, but several areas, including the cafeteria, emergency generator room, and several sub-basement shop areas, lack any coverage. The sprinkler heads in another area, the Southside Sundae Shop, were found to be non-functional because they were located above a false ceiling. In eight other locations throughout the building, the sprinkler heads were found to be blocked by the storage of cardboard boxes and other combustible materials stored too close to the heads. The OSHA standards require a minimum clearance of eighteen inches between the sprinkler head and any other object. See 29 C.F.R. §1910.159(c)(10); NFPA #25, §2-2.1.2.

*Missing ceiling tiles interfere with activation of sprinkler heads.*

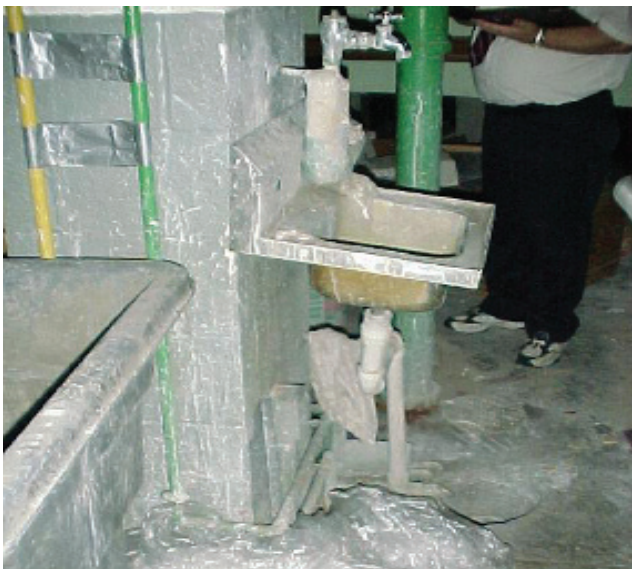
The number of electrical hazards documented in the Dirksen Building is exceptionally high as compared to other buildings. Hazards of an electrical nature constituted 116 of the 193 total violations documented in the Dirksen Building. The most serious resulted in the General Counsel issuing a Serious Deficiency Needing Prompt Attention Notice to the AOC on October 17, 2004, due to an undersink outlet lacking a ground fault circuit interrupter. The damp surfaces surrounding the sink area created a significant risk of electrical shock for employees working in this area.

*Outlet below sink without GFCI protection.*

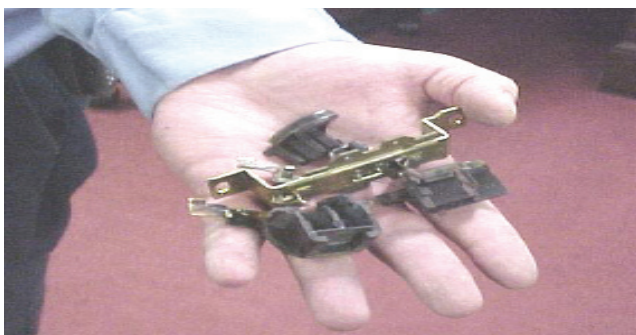
The team noted multiple instances of power strips and extension cords being inter-connected to create additional outlets for a work area; outlets requiring installation of GFCIs; broken outlets and receptacle covers; electrical devices with broken ground prongs; outlets with no ground protection; and exposed electrical contacts. In one instance, when the OGC inspector plugged a testing device into a regular wall outlet in the sub-basement, sparks flew out of the outlet, causing the circuit breaker to trip. When an AOC electrician examined the outlet, the contents fell out in pieces when the cover of the receptacle was removed.

*Contents of electrical outlet that fell out in pieces during inspection.*

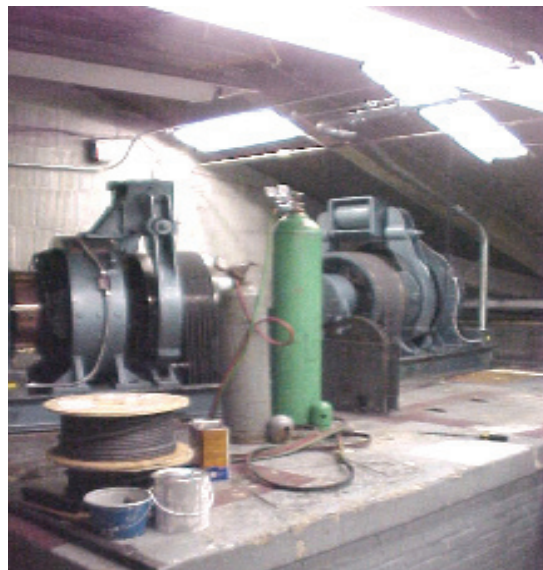
The significant risks associated with unsecured compressed cylinders is discussed in detail below. See Section V.A. The OGC inspection team found three instances in which compressed gas cylinders were not secured.

*Cylinders are not secured and will fall over easily.*

One cylinder contained acetylene, which is a highly volatile chemical. Another had its regulator attached which adds to the risk of valve damage should the cylinder fall. When valves are damaged, they frequently begin to leak. Damaged cylinders have been known to explode or to become missiles causing extensive damage and physical injury.

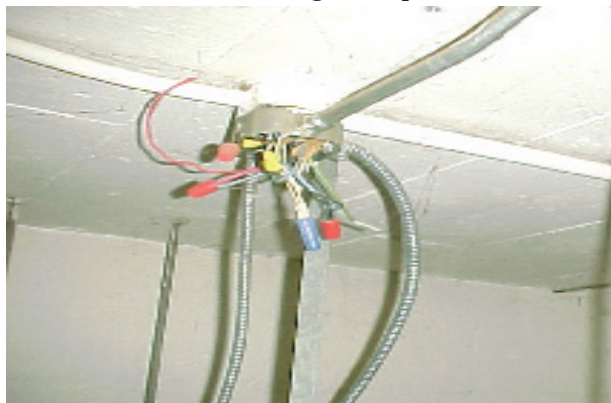
Hazards of an electrical nature constituted 35 of the 79 hazards identified by the OGC inspection team. Approximately, one-third of the electrical hazards involved missing cover plates.

*Faceplate missing off electrical junction box exposing energized wires.*

A missing cover plate represents a significant hazard because live parts are exposed and can result in electrical shock to employees who come into contact with the wires. Another risk is fire resulting when sparks and molten metal are not contained during a short-circuit or other electrical failure.

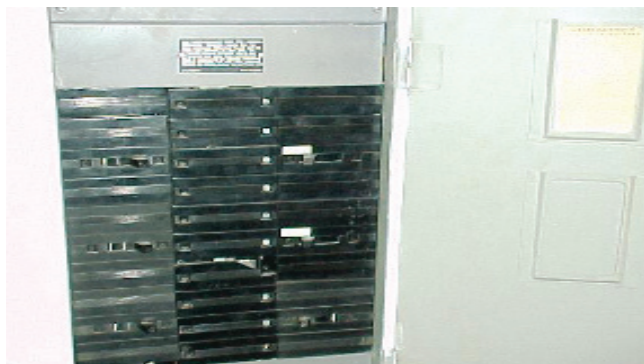
The electrical panels in three locations, Room B-37, Room B-24, and the Compressor Room, failed to have current circuit breaker directories.

*Circuit breaker panel is missing its directory/index.*

As was discussed in Section II.E. of this Report, it is imperative that electricians and emergency responders be able to quickly access the panel and access the location of the circuits in the event of emergency.

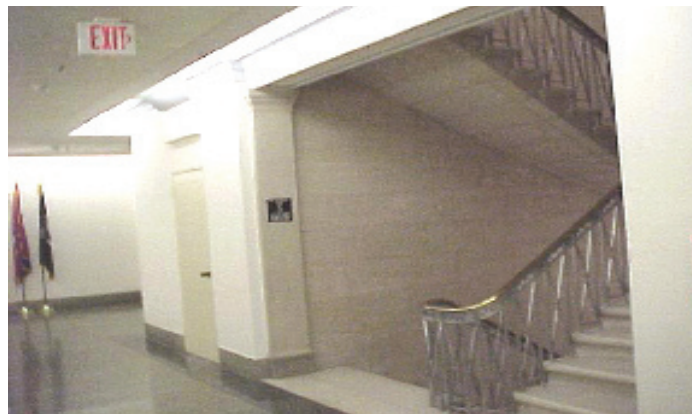
\*\*\*\*\*  
 \*\*\*\*\*  
 \*\*\*\*\*<sup>50</sup> The exit stairways in the Longworth Building lack protective enclosures and doors to the floors they service. No upper floor stairwells are enclosed. Some stairwells such as those in the Southeast (ground floor) and Southwest corners (sub-basement to basement levels) are only partially enclosed. None provide any protection to the upper floors in the event of a fire in the lower floors. The AOC was issued a citation in March 2000 for this very serious deficiency. The AOC has not scheduled abatement of this hazard until after 2008.

Open stairwells in Longworth House Office Building.

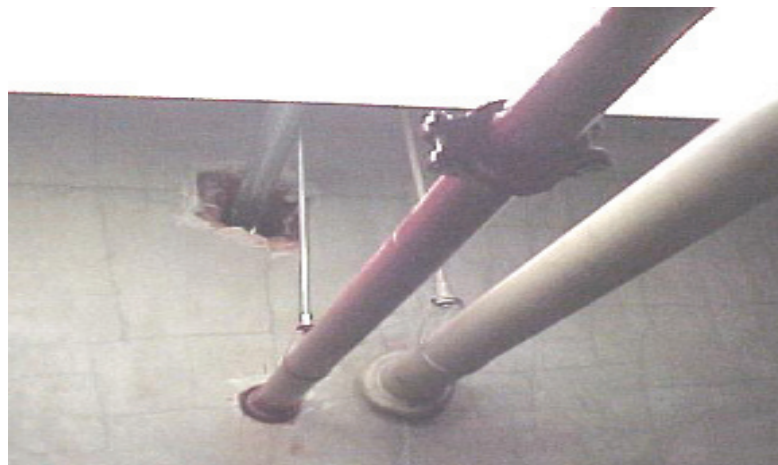
Holes were also found in nineteen fire barrier walls throughout the Rayburn Building. The locations include the Penthouse, basement garage, sub-basement, and three levels of the Rayburn Garage.

*Hole in fire wall allows penetration of toxic smoke.*

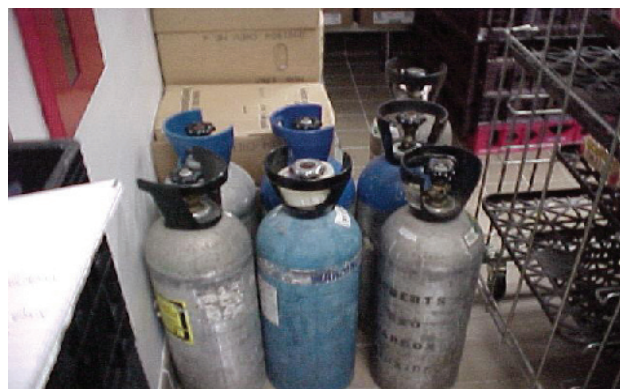
The inspection team found four instances of pressurized cylinders that were unsecured.

*Unsecured pressurized gas cylinders.*

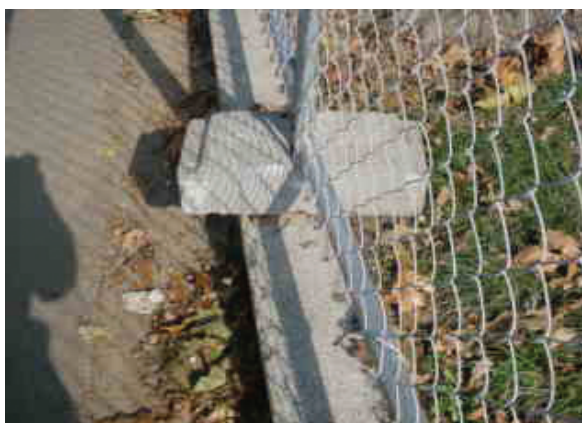
The other two incidents involved temporary security barriers surrounding a construction site at the Adams Library of Congress Building. Installing the security barriers around the building required the contractor to construct a temporary chain link fence around the construction area and the sidewalk along the edge of Second Street S.E. The first incident occurred in late October 2004. The fence blew over on an LOC employee who received cuts, abrasions, and torn clothing as a result of the accident.

*Temporary fence that fell over and injured people held up by cement block.*
