The Capitol Power Plant

111th Congressional Inspection Findings

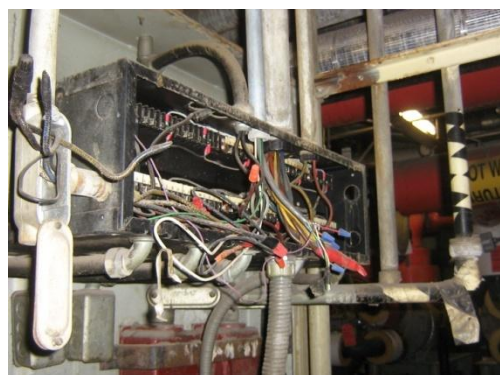
Picture 1: Back Electrical Cover Missing On Control Panel

to contact energized components inside the panel box.

Twenty-two electrical panel covers were discovered to be missing from electrical junction boxes leaving wires exposed that could cause electrical shock. See Picture 1. A number of electrical panels had incomplete or missing directories for the individual circuit breaker service. This has the potential to expose employees to hazards and may lead to serious injury if the wrong circuit is deactivated or locked out during maintenance or repair of equipment. Several electrical panels had missing or broken latches, leaving the internal mechanisms exposed to potentially corrosive dust. There were also several panels without a dead front, which could permit employees inadvertently

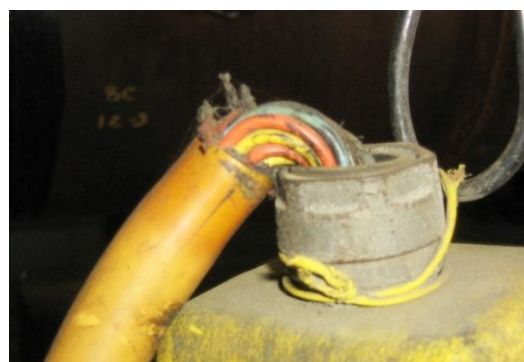
The inspectors noted ground fault circuit interrupters (GFCIs) missing from two electrical outlets near sinks in the basement of the Boiler Building. A GFCI on the first floor of the building was broken and would not trip. Inside a restroom near a sink, a GFCI was found loose in its bracket. Further problems with electrical cords were also noted. See Picture 2.

Picture 2: Electric Cord Pulled Away From Mounting

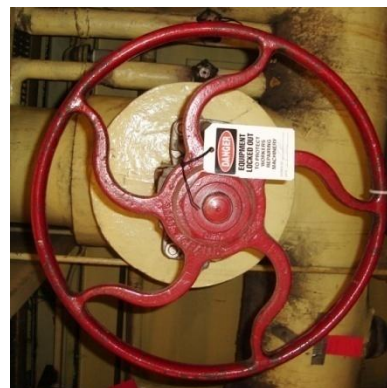
Lockout/Tagout deficiencies were observed during the inspection. The Power Plant does not appear to have implemented a comprehensive Lockout/Tagout program that complies with OSHA standards. This hazard was observed during the 110th Congress biennial inspection. During the 111th Congress inspection, the inspectors recorded these hazards as one general finding that an adequate program had not been implemented. This hazard puts employees at risk of injury from electrical, mechanical, thermal or stored energy including high voltage equipment. If these energy sources are not neutralized or controlled, equipment could accidentally start up during maintenance or repair, causing fatality, amputation or other serious injury. An unplanned startup could also damage CPP equipment or property. See Picture 3.

Picture 3: Valve Needs To Be Locked Out, Not Just Tagged

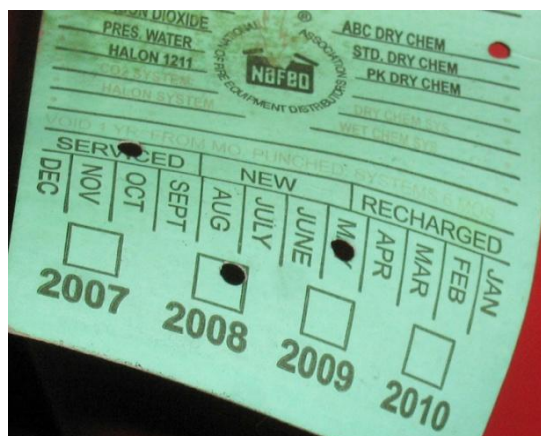
Picture 4: Tag On Portable Fire Extinguisher Indicates Last Inspection in 2008

The inspectors found six locations where fire wall openings would allow the penetration of smoke and toxic gases into an adjacent fire zone during a fire. Five instances of unsafe electrical space heaters were discovered. Four instances were recorded where lighting cables were not reconnected to the ground cables after work had been completed in those areas. Portable fire extinguishers were discovered that had not been inspected in over two years. See Picture 4.

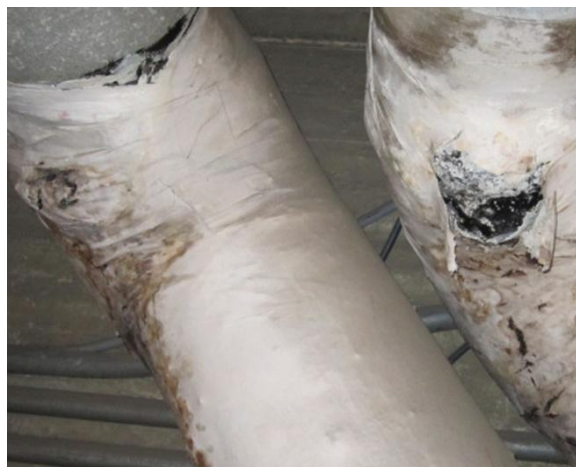
Each building serviced by the CPP has a vault or room known as a steam station where high pressure steam is reduced to a lower pressure and distributed throughout the building. The inspectors found a number of hazards in these areas, including friable asbestos lagging, a failure to test pressure relief valves, and potential weakness in steam lines due to corrosion. See Picture 5.

Picture 5: Cloth Pipe Lagging Covers Are Ripped Open Exposing Friable Asbestos Insulation

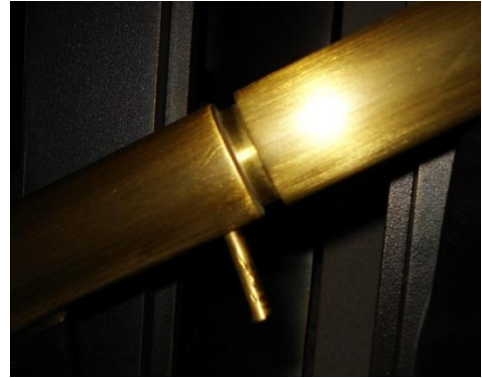
confined spaces that lacked required warning signs. However, AOC indicated the areas will be evaluated and signs installed by the end of 2011. Four instances were found where space heaters lacked a protective tip-over switch. Only one instance was found for inadequate machine guarding and one instance was found for an unlabeled hazardous chemical container. Picture 1 displays a connector pin protruding from a newly installed handrail. This pin could easily injure a person's fingers. After inspectors brought this problem to the AOC's attention, contractors quickly sawed off the pin and made the surface smooth.

Picture 1: Brass Connector Pin Protruding From Handrail

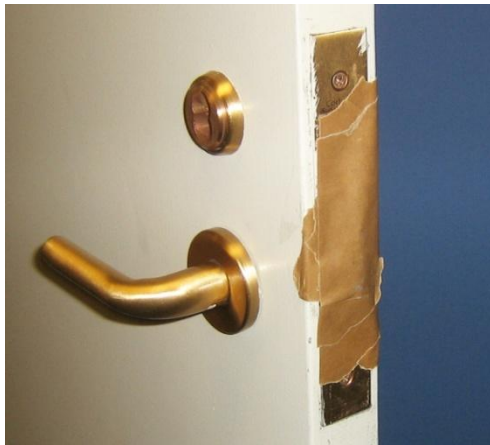
close and latch by themselves in an emergency so that fire, smoke and other toxic gases do not easily move into other fire zones. Picture 3 is a push-to-talk device in a stairwell so that building occupants can easily contact the U.S. Capitol Police in an emergency if they need assistance. This device is well-marked and readily accessible to Members, staff and visitors alike. Picture 3 is an excellent example of a system that meets OSHA and fire code requirements.

Picture 2: Fire Door Latch is Taped Open

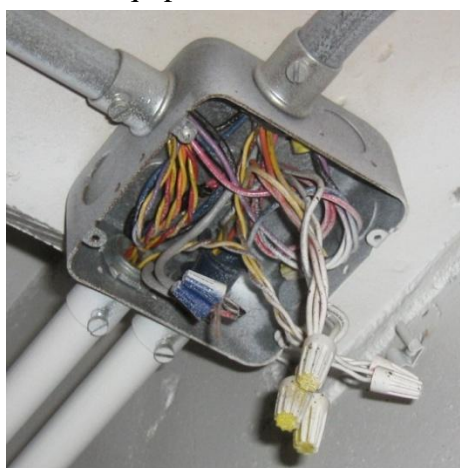
Electrical hazards were the most common findings across all RAC levels. Of the 52 RAC 2 electrical findings, there were 26 missing electrical covers (See Picture 1), 9 electrical outlets and switches, 7 miscellaneous electrical hazards, 7 electrical panels hazards, and 3 improper use of extension cords. The inspectors found 41

Picture 1: Open Electrical Junction Box

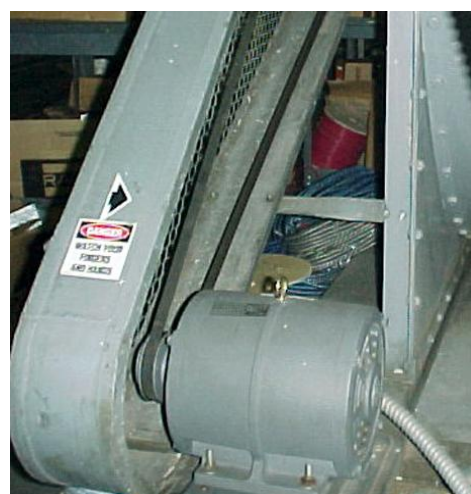
The 111th Congress inspection identified four machine guarding hazards. See Picture 2. This was 42% lower than the number of such hazards found in the previous Congress. The fire sprinkler system presented multiple hazards, including non-approved Omega sprinkler heads, sprinkler heads that had been spray-painted, and others that were covered with dust and dirt. In one case sprinkler heads had been installed upside down. The team noted a lack of required documentation stating that the fire sprinkler system is visually inspected annually and tested periodically.

Picture 2: Inadequate Guard Over V-belt & Pulley

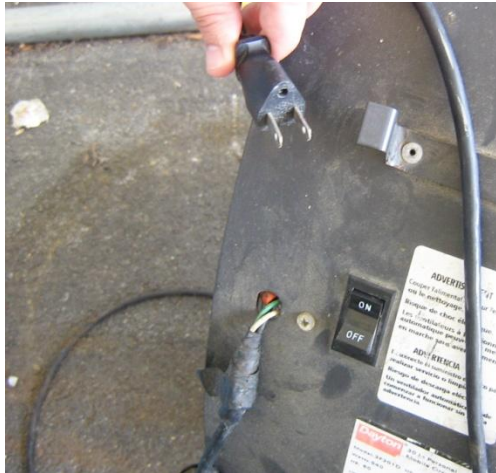
Picture 1: The Plug Is Missing A Ground Prong & The Cord Has Been Pulled From The Device

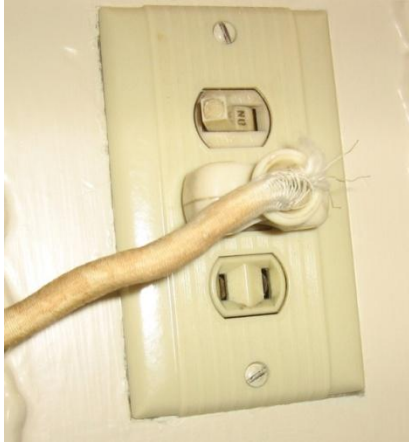
Picture 1: Two Prong Electrical Outlets Must Be Replaced With 3 Prong Outlets

The inspection team noted 12 GFCI violations. These hazards could cause electrical shock. Four electrical junction boxes had exposed wires and lacked a firmly affixed cover. There were six electrical panels missing breaker position covers or lacking a dead front. This was a 40% decrease from the 110th Congress. These deficiencies were remedied during the inspection cycle. The team found a number of two-prong outlets, which are hazardous because they are not grounded. See Pictures 1 and 2.

These old style receptacles were later replaced with three-prong, grounded outlets.

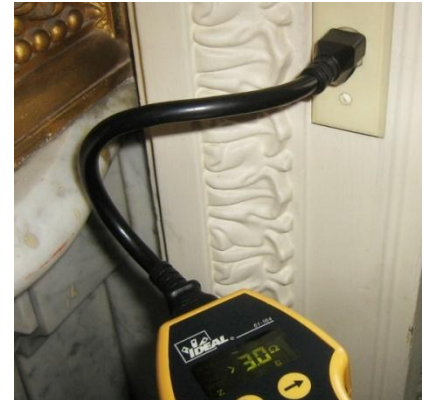
Picture 2: Displays Receptacle With High Impedance

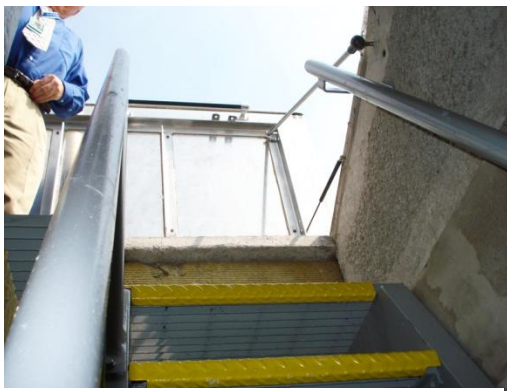
A notable remaining example of a slip and fall hazard is a historic spiral staircase that connects the ground floor of the Capitol with the second floor. There is no handrail and the steps are worn, creating a potential hazard. This finding was noted during the 110th Congress and continued into the 111th. The OOC has been informed that fabrication of the handrail is underway. Walking on a steep and at times wet and slippery metal roof was the only means to access the flag pole on the east front. The AOC constructed a stairway and hatch from the attic to the roof near the flag pole for safer and easier access. See Picture 3.

Picture 3: Example Of An Excellent Solution To A Fall Hazard

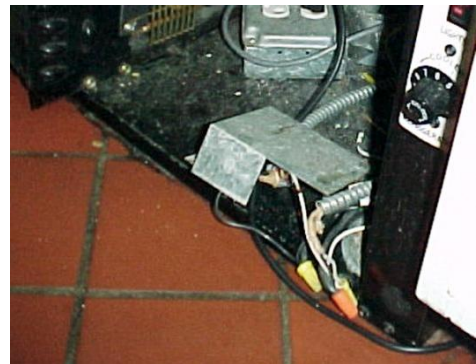
As Figure 5 indicates, 50% of the hazards that the team found involved electrical issues. These hazards include deficiencies with outlets, electrical covers, cords, plugs and electrical panels. See Figure 6. The inspectors noted a high incidence of exposed live wiring behind outlets and switches, as well as in damaged cords and plugs. See Picture 1. The team found 56 Ground Fault Circuit Interrupter (GFCI) hazards, including 13 broken GFCIs. These devices can quickly cut the power when a short is detected. Forty-three locations were identified where GFCIs should have been installed and were not. In 35 of these cases, outlets located less than six feet from a water source lacked requisite

Picture 1: Open Electrical Box.

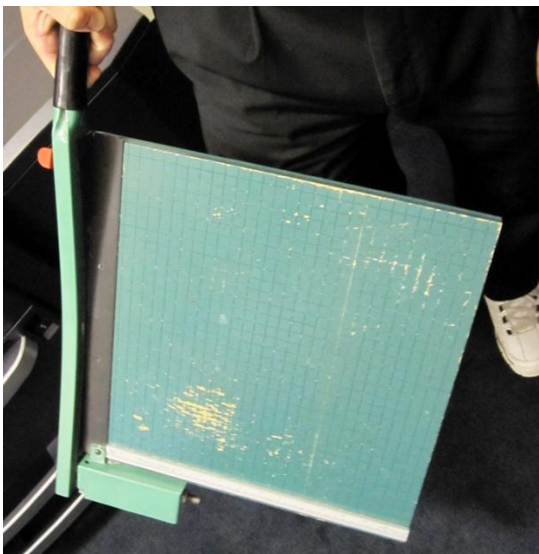
The inspectors found nine hazards associated with missing or inadequate machine guarding. Although this represents a small percentage of the total, see Figure 5, these hazards can be very serious. Inspectors found paper cutters that lacked appropriate finger guards. See Picture 2. The team also identified missing or broken guards on portable electric fans. In workshops, the team found several saws and bench grinders that lacked guards to prevent the operator from reaching into the point of operation.

Picture 2: Missing Finger Guard

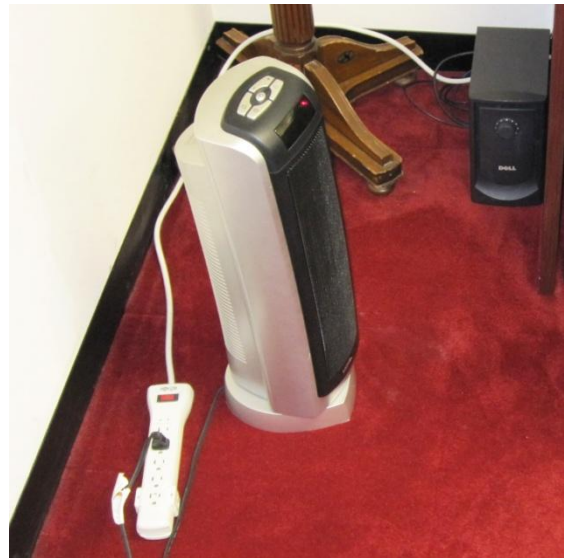
Fire safety hazards were documented in 329 findings. Problems with portable electric space heaters accounted for 105 findings. See Picture 3. Ten of the space heaters had broken parts such as legs or mounts. Most lacked a tip-over switch to shut off the heat if the device were turned on

its side; this prevents the coils from heating carpet or flooring to the point of catching fire. The inspectors found 18 such heaters in the Cannon Building, 23 in the Ford Building and 50 in the Rayburn Building. We understand that the CAO has prepared a list of space heaters featuring tip-over switches that could replace the non-compliant devices.

Picture 3: Portable Space Heater No Tip Switch

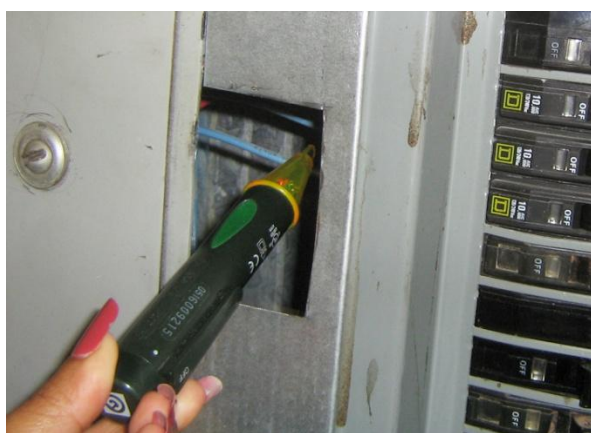
Figure 5 illustrates the breakdown of findings by hazard category or class. Electrical hazards are the most common findings, comprising 52% of the total. Fire safety hazards made up roughly 32% of the total, while the remaining findings were distributed among a number of categories. Electrical hazards include damaged or severely pinched electrical power cords, broken or burned outlets and switches, and junction boxes that were missing covers. The AOC is updating the electrical panels' directories, although the work is not yet complete. The maintenance of electrical panels remains a problem. Many panels are unlabeled or mislabeled. In addition, access to a number of electrical panels is blocked, which poses a threat in case of an emergency. Picture 1 displays an opening in an electrical panel circuit breaker box and energized contacts are exposed.

Picture 1: Electrical Box Hole Exposing Energized Contacts
