# **BIENNIAL REPORT 111<sup>th</sup> CONGRESS**

## **AMERICANS WITH DISABILITIES ACT INSPECTIONS RELATING TO PUBLIC SERVICES AND ACCOMODATIONS**

**Office of Compliance  
August 2012**

# **Accessibility in the Legislative Branch – Report on Americans with Disabilities Act Inspections Relating to Public Services and Accommodations during the 111<sup>th</sup> Congress**

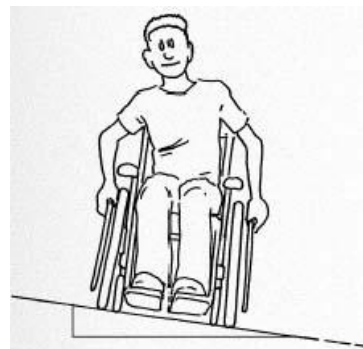
The OOC identified 31 sidewalk areas with cross slopes that are too steep. Of these, 18 areas are so steep that they have been rated as an “A” severity. In the remaining areas, 9 are rated as a “B” severity and 4 are rated as a “C” severity. Severe cross slopes make it difficult for wheelchair users and other pedestrians to maintain their balance because they must work against the force of gravity. People using crutches or canes may be forced to turn sideways in order to keep their base of support at a manageable angle. Cross slopes can also cause wheelchairs to veer to the side, which increases their risk of rolling into the street. The effects of cross slopes are compounded when combined with steep grades and uneven surfaces.<sup>12</sup>

**Wheelchair Users Find Severe Cross Slopes Difficult to Navigate**

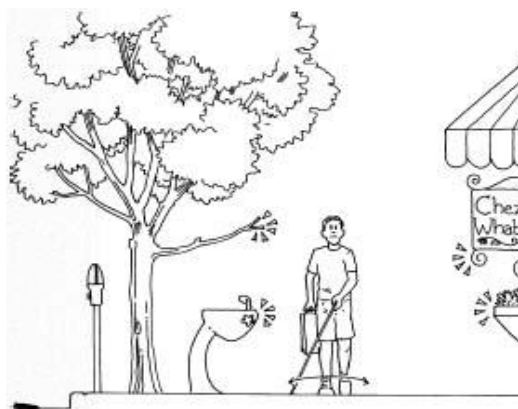
**In the Above Illustration, the Tree Branch, Water Fountain, Sign and Planter Are All Protruding Objects that Are Access Barriers for Cane Users**

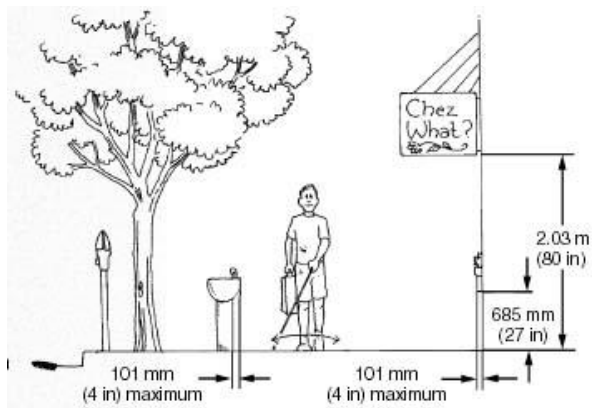
**This Illustration Shows How the Barriers in the Previous Illustration can be Modified to Provide Access**

Protrusions should be minimized as much as possible in each situation. Furthermore, because pedestrians with vision impairments do not always travel in the pedestrian zone, protruding objects should be eliminated from the entire paved portion of the sidewalk corridor. Protruding objects do not need to be eliminated if they are separated from the sidewalk corridor with a planting strip or other type of setback.
