*Office of Compliance*  
**Report on Occupational Safety  
and Health Inspections**

Conducted in the Legislative Branch during the 108th  
Congress pursuant to the Congressional  
Accountability Act

*October 2005*

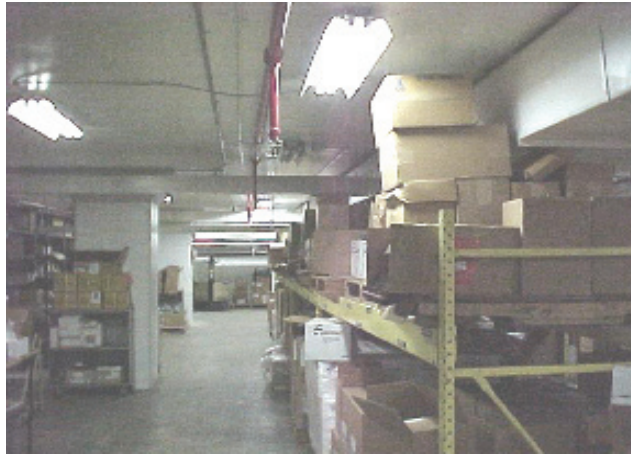
*Combustible materials stored above sprinkler heads.*

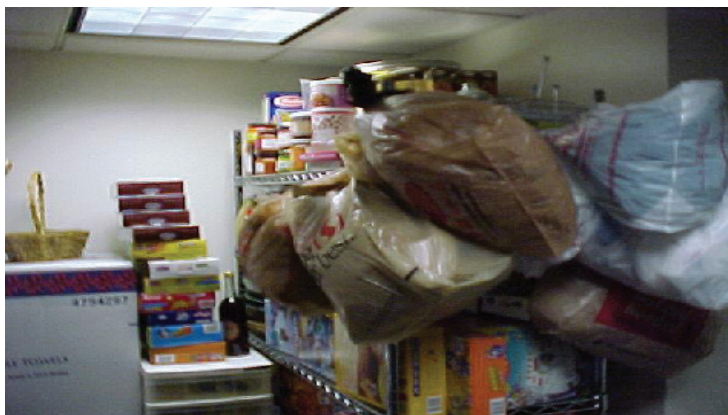
The Hart Building still lacks complete sprinkler coverage, such as in one work area of the Construction Management Division. In several locations, combustible materials were also found to be stored closer than eighteen inches from the sprinkler heads. As previously noted, OSHA standards require a minimum clearance of eighteen inches between the sprinkler head and any other objects.

*Unstable stacking of items on shelf and there is no sprinkler coverage in area.*
