The Capitol Power Plant

111th Congressional Inspection Findings

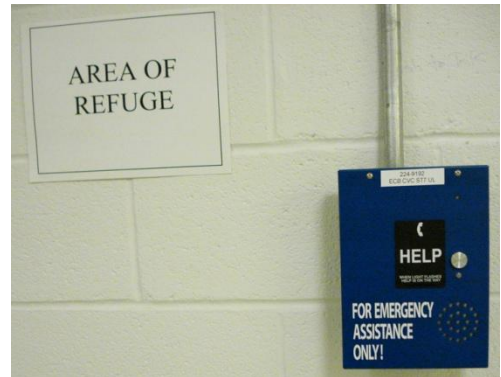
Picture 3: Excellent Emergency Communications System
